# When stones are no longer stones

E. Zapatero

*Architect, PhD Student at the Polytechnic University of Madrid (UPM) ETSA  
DCTA, AIPA*

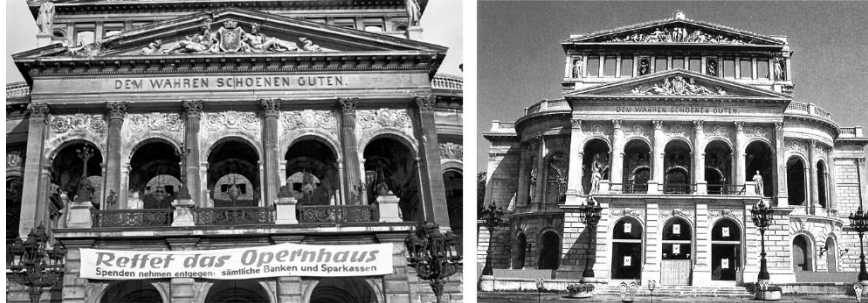
Figure 1: Old Opera in Frankfurt: Matter in its appearance shows traces of World War two (Picture: K. Liese, Harald-Reportagen)

Figure 2: Old Opera in Frankfurt: Substitution techniques erase war traces, damaging documentary value of matter in its appearance (Picture: Brix [5])

Another case where this technique was applied extensively was in Frankfurt's Old Opera building. After the 1944 bombing, the inside of the building suffered extensive damage, leaving only the building envelope standing. The restoration of the building was commissioned in 1971 to the architectural firm Braun & Schlockermann, and included an ambitious cultural program inside the building. Replacement techniques are applied in the consolidation of the south facade on approximately 1500 m<sup>2</sup> of sandstone (Brix [4]).

When replacement techniques are used, the matter in its appearance is removed, damaging its documentary value irreversibly. In the examples shown, the main goal was to eliminate the traces of the war. However, this technique has also eliminated other documentary values like patinas, quarry marks, damages, etc. that enable the study of the age of the building, its process of creation and transformation, etc. When these techniques are applied over extensive areas, as is the case of the examples described, one can achieve a complete replacement of

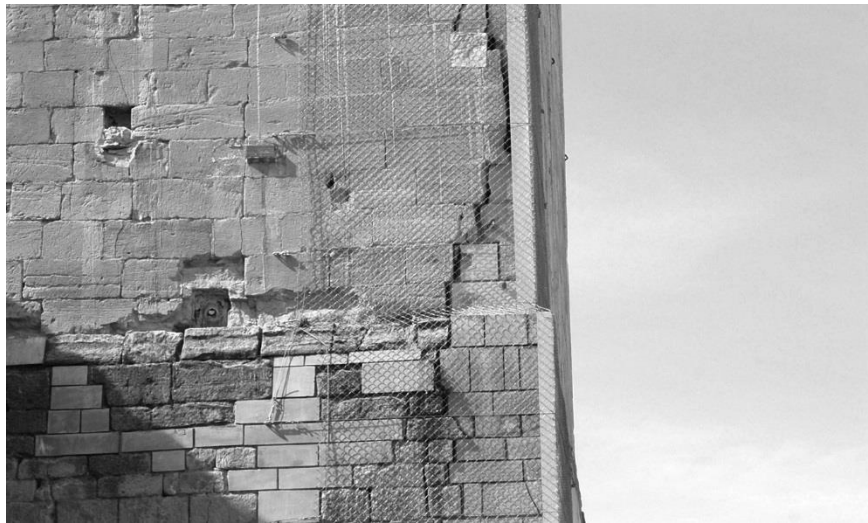
Figure 5: Tower of "*Sta. Maria de Alcocer*": Damages caused by incompatible consolidation techniques manifest on matter in its appearance

The consolidation over the tower of the “*Sta. Maria de Alcocer*” Church is an example of the damage that this technique can cause on historical masonries. Incompatibility between the new material and the historic masonry manifests in the image of the masonry and in the matter in its appearance through cracks and rejection of its material. Over time, the materials and execution process from this technique has been improved, and is now capable of keeping the image of these masonries and their matter in its appearance unaltered. However, although the damage may not be visible, matter in its structure is destroyed irreversibly. These stones that look like stones ceased to be stones belonging to an isostatic mechanical system, and became material in a new statically indeterminate mechanical system which is strange to them. In this new matter, the original meaning from these stones is lost. This new decorative function is misleading, since matter in its appearance is made up of these stones, with their patina, their damages, quarry marks, appearing to still be what they once were. However, when stones are no longer stones, we can no longer rely on them, study them and let them reveal us the secrets about how they work. We will be limited to study what the history books say.
